RAILWAY INVESTIGATION REPORT
R02D0113

MAIN-TRACK DERAILMENT

CANADIAN NATIONAL
TRAIN M-366-31-22
MILE 86.43, SAINT-MAURICE SUBDIVISION
HIBBARD, QUEBEC
24 OCTOBER 2002

Report Number R02D0113

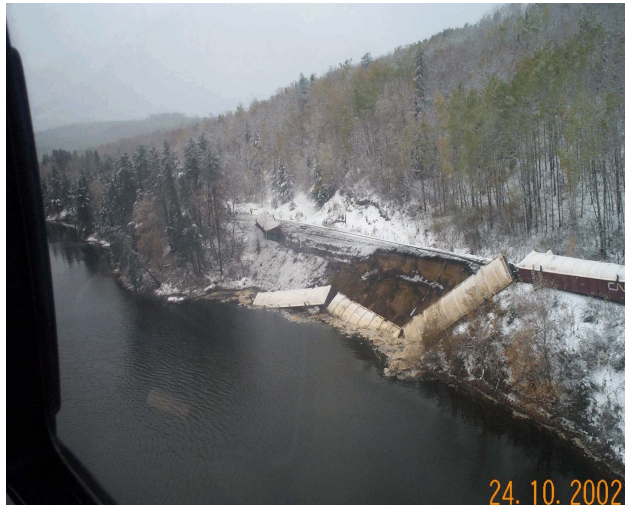
The lead locomotive stopped at Mile 87.58. The first derailed car (102nd car), gondola car CN 137187, remained upright and coupled to the forward portion of the train. The next five cars uncoupled, and three of them descended the track embankment and came to rest at the edge of the lake beside the track (see Photo 1). The derailed cars were damaged and 275 m of track was destroyed. A dike was set up around the derailed cars to recover the ore and clean up the accident site.

Photo 1. Derailed cars

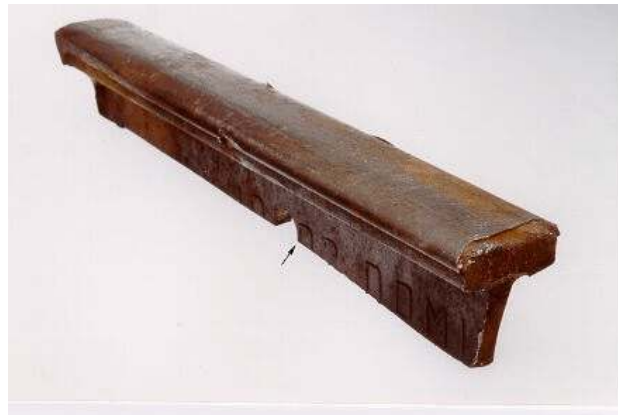
The first piece of rail had a longitudinal fracture in the web running through an old splice bar bolt hole drilled through the rail web and intersecting the "0" of the rail markings (see Photo 2). The hole showed no abnormal wear or ovalization, and its edges were not chamfered. Metallurgical analysis of one section taken from the edge of the hole revealed decarburization of the metal surface. The fracture surface was relatively flat and uniform. It revealed grain deformation and sub-surface cracking consistent with long-term pounding wear.

Photo 2. Splice bar bolt hole and web fracture

Laboratory testing revealed that cracks originated on either side of the splice bar bolt hole and propagated longitudinally through the rail web. Decarburization of the rail around the splice bar bolt hole indicates that heat was applied to the metal during the hole drilling process. Further, the splice bar bolt hole intersected the rail markings, and the edges of the hole were not chamfered. Consequently, the hole presented a site for mechanical and metallurgical stress raisers and contributed to the initiation and propagation of cracks.

1. The south rail failed as the train rolled over it, causing the cars to derail.
2. The longitudinal fracture in the rail was present for some time, and originated at a splice bar bolt hole that acted as a stress raiser, since it intersected rail markings, its edges were not chamfered, and it had been heated in the drilling process.

In June 2003, Canadian National adopted a new policy requiring that partly worn rail be ultrasonically inspected for internal defects if it is to be laid on Class 3 tracks or higher, including plug rails. If the inspection is not done before the rail is installed, the rail must be degraded to Class 2 until the inspection is completed.
